O POLARIS	TECHNICAL SERVICE BULLETIN		
Date: March 21, 2017	ATV	Bulletin Number: A-17-01-C Model Years: 2015 - 2016	
Safety Bulletin	Service Bulletin	Service Alert Fax	
	☐ Service Manager ☐ Sales Mana vice Bulletin is located at www.polaris -Confidential and Proprietary-	ager

## **IMPORTANT STOP RIDE / SALE SAFETY NOTICE!**

2015–2016 Sportsman 850 1-Up Thermal Protection Update

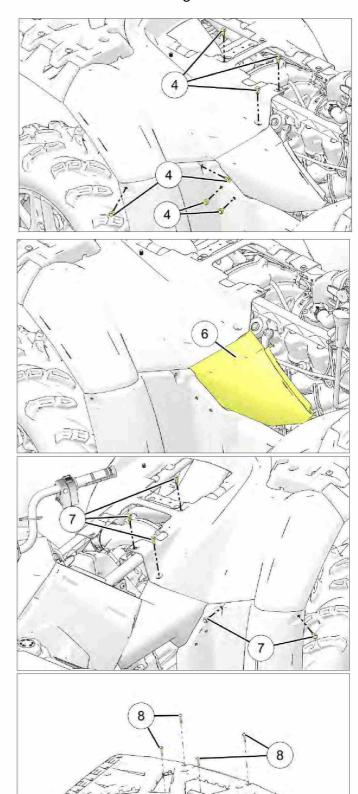
Remove the exhaust manifold side panel and discard
 6.

Pull the front edge of the rear cab away from the vehicle and slide the exhaust manifold side panel 6 forward to remove.

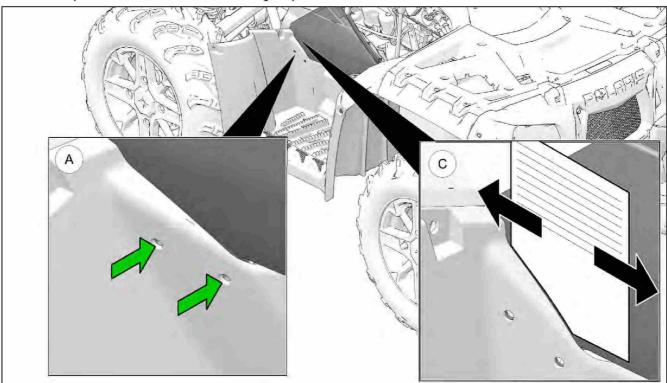
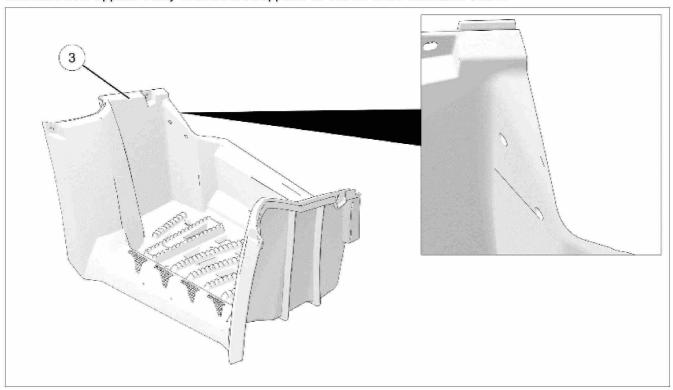
A secondary dealer representative must verify that the trimmed edge of the footwell does not contact the new exhaust manifold side panel.

If a piece of paper does not freely slide between the panels, continue to trim the panel using a half round file until the paper passes freely the entire length of the gap.

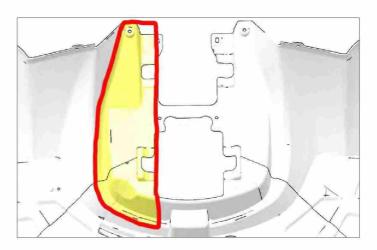
There are holes/slots punched in the foil material to allow seat venting/draining. Ensure all punched out areas have any remaining material removed prior to installation.

Thoroughly clean the highlighted surface of the rear cab with warm soapy water and a sponge. Dry the rear cab with a lint free cloth.

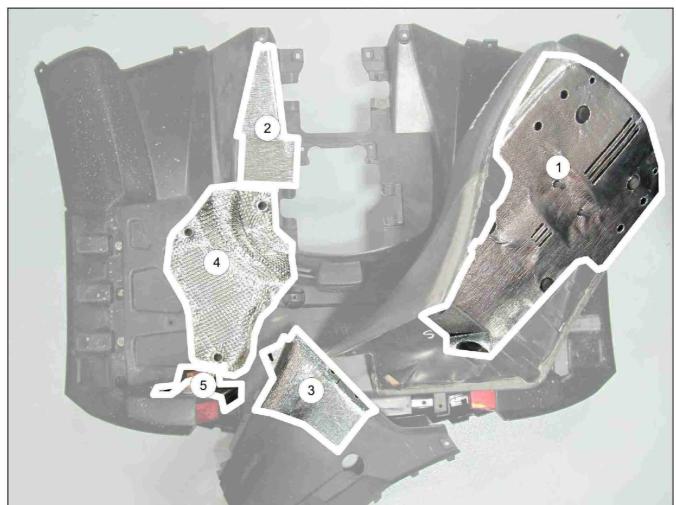
12. Take a picture of the cab, side panel, and seat so that all heat shields/foils on these components are visible. This is one of two pictures required to submit the warranty claim.

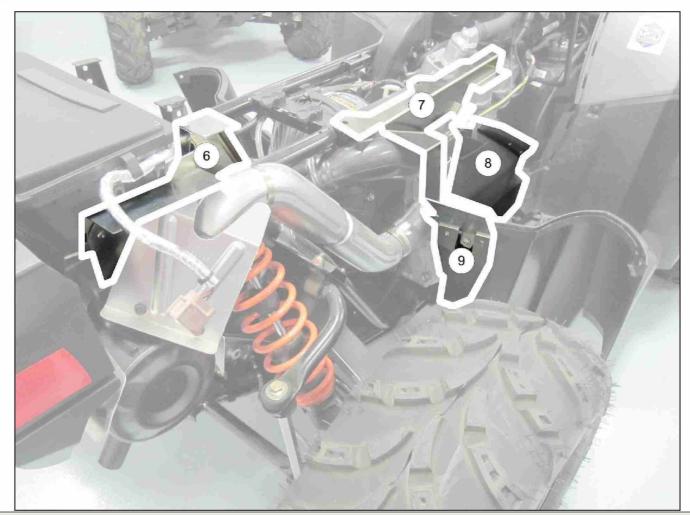
11. Take a picture from just above the right rear wheel, pointing toward the center of the machine. Ensure that all heat shields/foils installed are visible. This is one of two pictures required to submit the warranty claim.

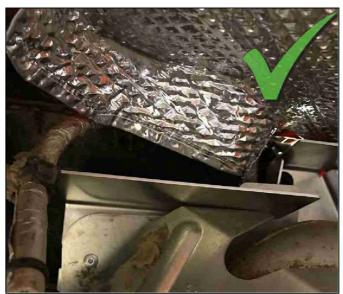
A secondary dealer representative must verify the Rear Cab Heat Shield is bent down and wraps around the corner of the Storage Box and Tail Light Harness. If it interferes when installing the cab, ensure it is bent back down to match the good example below.

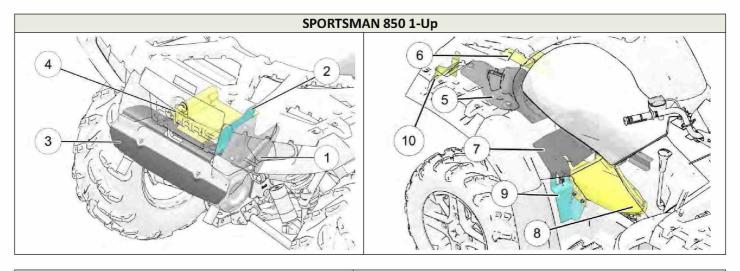
## PART 5: A-17-01-C HEAT SHIELD INSPECTION

If any of the components are found to be missing or damaged, take photos of the affected components and submit an ASK Polaris case for replacement approval.

A secondary dealer representative must verify that all new heat shields have been installed and all old heat shields have been inspected for damage.

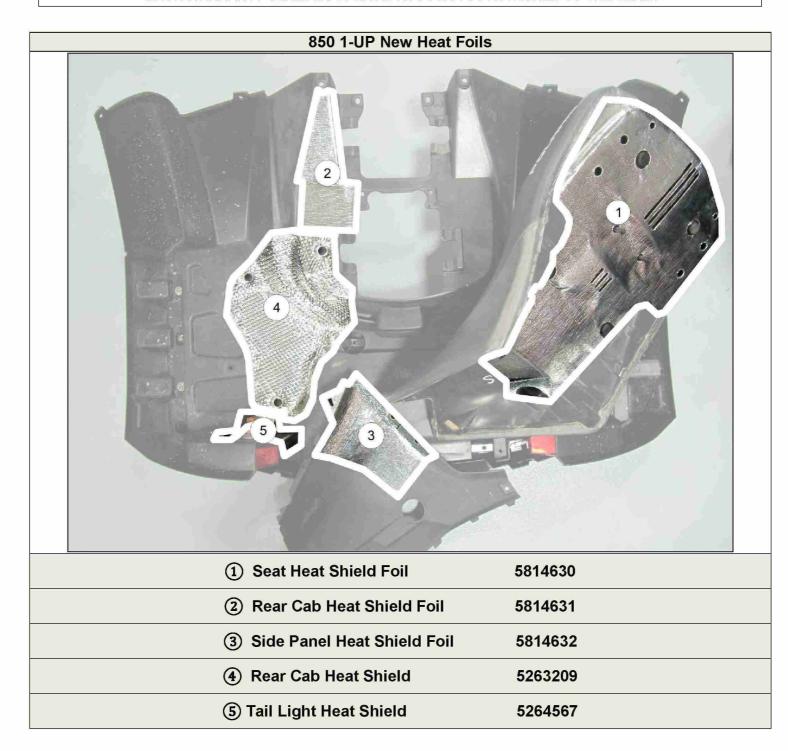
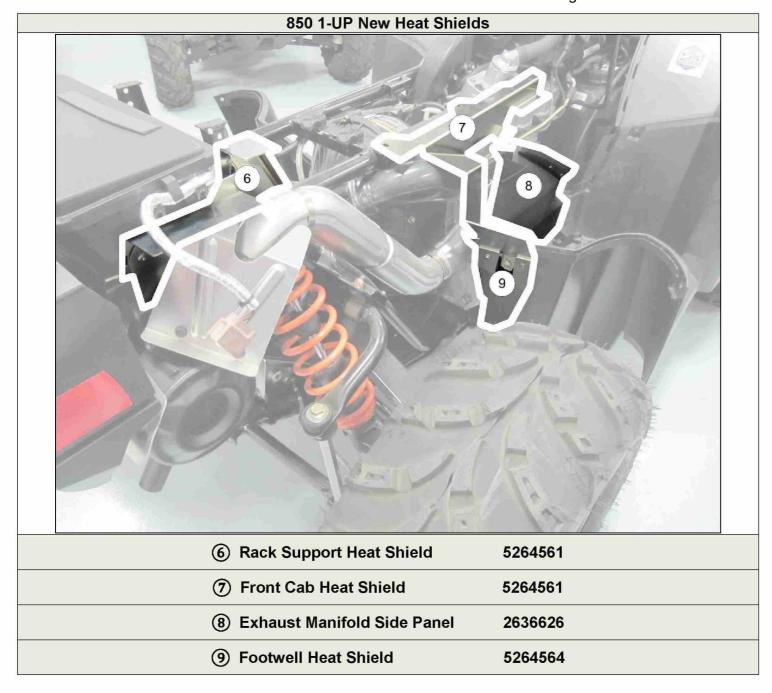
Two photos are required for warranty claim submission. A secondary dealer representative must verify both pictures to ensure proper final heat shield inspection. Examples of both images required are included on the following pages.
